FM BROADCAST TRANSMITTER REPAIR & ANALYSIS REPORT

Rev 1.0 · April 2026 · caslab.science

DEVICE	Homebrew PLL FM Broadcast Transmitter (FRB micropower design)
PLL IC	Motorola MC145151P2 (CTGD0404, 28-DIP CMOS)
VCO	Mini-Circuits POS-150 (100-150 MHz, +7 dBm, shielded module)
XTAL	8.400 MHz HC-49 — R=42 — f_ref = 200 kHz/channel step
DRIVER	2SC1970 (C1970 99AA, TO-92 VHF NPN, main board)
PA	2SC1971 (C1971 06AR, TO-39 VHF NPN) — HEAT DAMAGED
LPF	7-element Chebyshev (3 air-core coils + 4 x 27 pF shunt caps)
SUPPLY	13.8 V DC in -> LM2940CT-12 (+12 V) -> 78L05 (+5 V logic)
STATUS	PA sub-board heat damaged — full repair required before operation

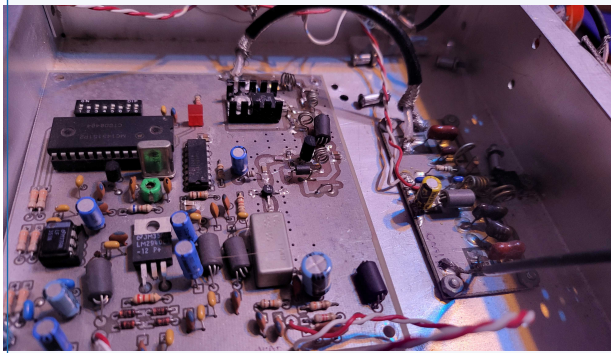
FIG 1 — Full interior. Main PLL board (left), PA sub-board (right). LM2940CT-12 regulator visible lower-centre. Coax feeds to right.

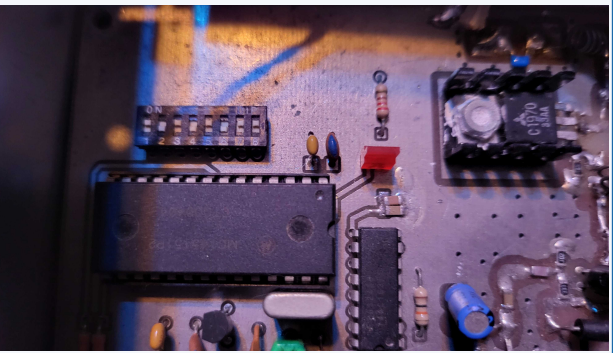
FIG 2 — Main board detail. 8-pos DIP switch (all OFF), MC145151P2 PLL (28-DIP), red power-on LED, and 2SC1970 driver transistor (TO-92, upper-right).

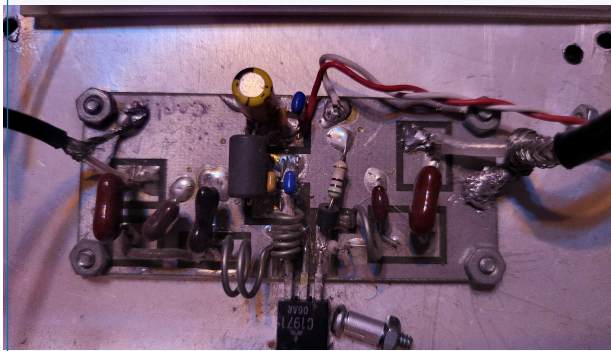
This report documents the reverse-engineering and repair analysis of a homebrew FM broadcast transmitter of the Free Radio Berkeley micropower PLL design family. All major components have been identified from photographic inspection. The PA sub-board exhibits heat damage consistent with a failed 2SC1971 power transistor — likely caused by sustained operation into an open-circuit or high-SWR antenna load.

FIG 3 — PA sub-board. 2SC1971 (C1971 06AR, TO-39) at bottom-centre. Hand-wound air-core matching coils visible. Yellow decoupling cap at top.

2SC1971 is pin-compatible with 2SC2078 (preferred), 2N3866 (TO-39 metal can, excellent), and NTE107. The 2SC2078 may come in TO-92 or TO-39 depending on manufacturer – always verify pinout (B-C-E vs E-C-B) against the datasheet before soldering.

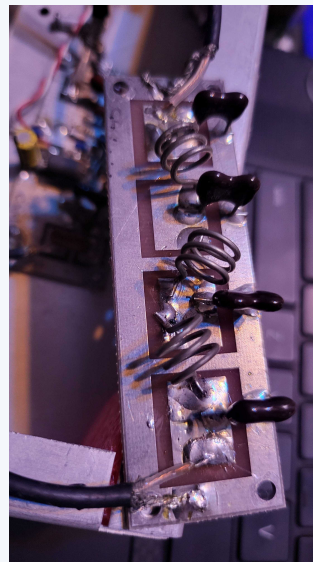
FIG 4 — 7-element Chebyshev LPF. Three bare-wire air-core coils (5T #18, 1/4" dia) with four 27 pF black ceramic shunt caps.

Air-core coil leads of stiff #18 wire exert mechanical stress on PCB pads during thermal cycling. All six coil-end joints (two per coil, three coils) should be re-tinned with fresh rosin-core solder even if they appear intact visually.

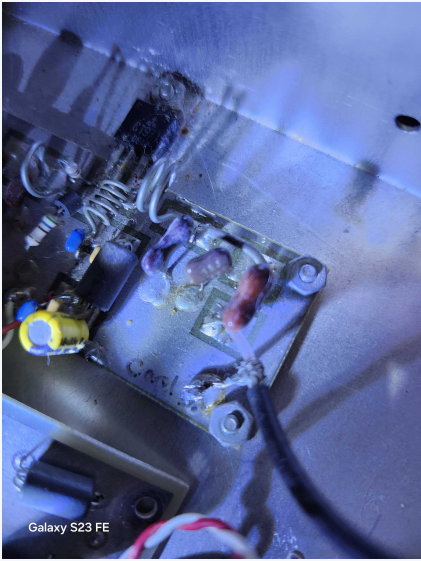
FIG 5 – PA sub-board heat damage. Scorching and PCB discoloration clearly visible. All burnt passives must be replaced before re-use.

STOP	Do NOT power on until steps 1-4 are complete. PA board has confirmed heat damage.
Step 1	Remove PA sub-board. Under magnification, identify all burnt/discoloured components. Photograph before desoldering.
Step 2	Desolder Q2 (2SC1971). DMM out-of-circuit: Vbe forward = 0.55-0.70 V. Any reverse conduction on C-E or B-C = failed junction, replace transistor.
Step 3	Replace all burnt resistors and capacitors on PA board. Re-tin all air-core coil pad joints.
Step 4	Locate 78L05 (TO-92 near U1). Verify OUT = +5.0 V. Without this the PLL cannot run.
Step 5	Set DIP switch per frequency table (Section 5). Confirm switch polarity with DMM first.
Step 6	Connect 50 ohm dummy load to SO-239. Do NOT use an antenna until dummy-load tests pass.
Step 7	Power on. Verify LM2940CT-12 OUT = +12.0 V. Verify 78L05 OUT = +5.0 V. LED D1 lit.
Step 8	Scope U1 pin 26 (OSCin): 8.400 MHz sinewave, 0.5-1.5 Vpp. No signal -> check C3/C4.

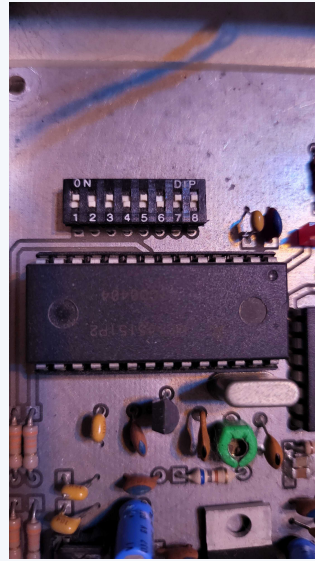
FIG 6 – DIP switch detail (all 8 positions OFF). Must be configured to correct N-counter binary value for target FM frequency before use.

Whether DIP switch ON = HIGH or LOW depends on external pull-up/pull-down resistors. Measure each pin voltage while toggling before setting frequency. The table in Section 5 assumes ON = HIGH = bit included in N-counter value.

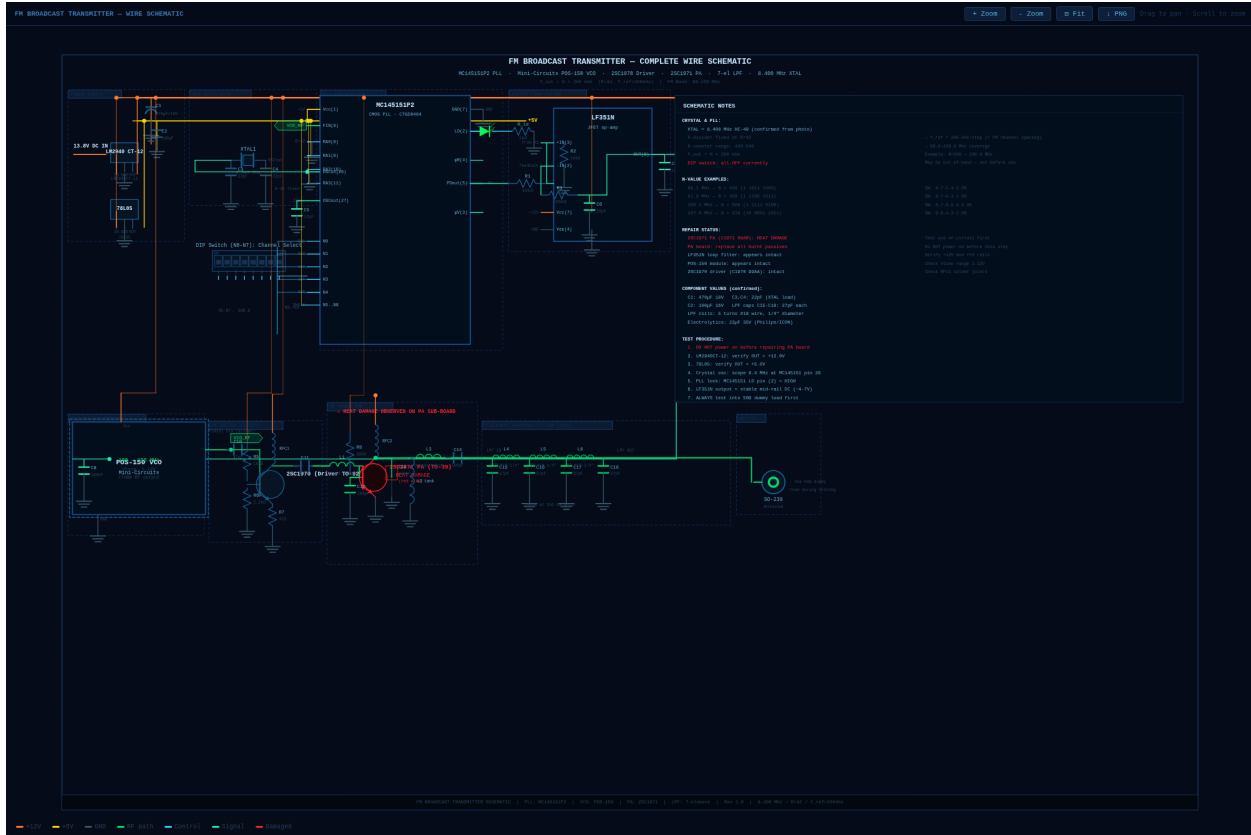
FIG 7 – Complete wire schematic. $f_{out} = N \times 200 \text{ kHz}$ (8.400 MHz crystal, R-divider = 42). Green = RF path. Blue = control/DIP. Orange = +12 V. Yellow = +5 V. Red = damaged section.
